ICC-ES Recognizes Innovative Solutions to Industry's Stair Rail Safety Concerns

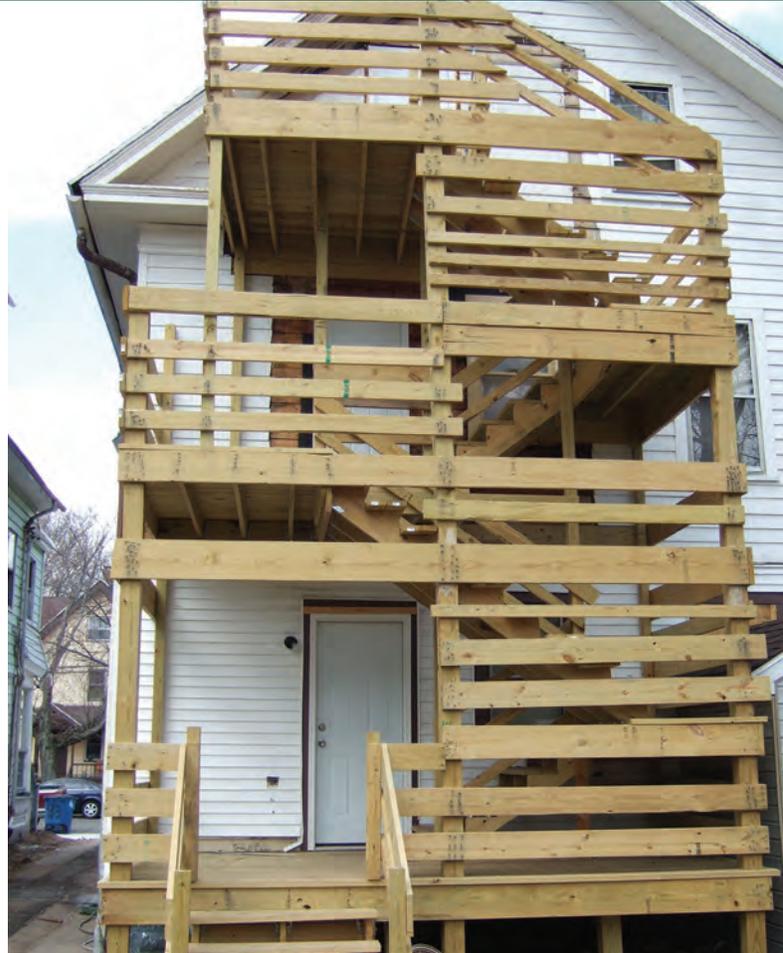
How Not to Build a Deck

Photo Credit: James Eggert, Building Inspector, City of New Haven, CT

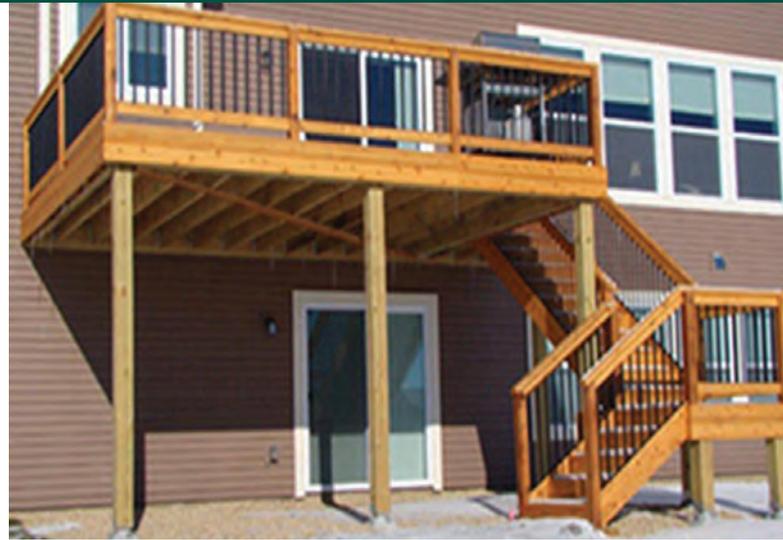
“The results were surprising,” said Truckner. All three tests consistently showed significant structural failure occurring at minimal loads and several reasons for the early failure were identified. The post acted as a lever against the stringer, magnifying the load on each bolt. A 20-pound pull at the guardrail level resulted in a 120-pound force at the base of the post and caused the top bolt to pull through the stringer. Once the top bolt had broken through, the bottom bolt was left to resist the entire load. The mechanical advantage was further amplified by the lower position of the bottom bolt, and the final 50-pound pull on the guard rail became a 1,200-pound force at the base. This was enough to twist the stringer and cause it to crack longitudinally. “It must be pointed out that these tests

were conducted on isolated posts without railing,” Truckner explained. “Often, a continuous rail is used, which can help to distribute the load to other posts, decreasing the load effects on the bolts at a single post attachment. However, the test was designed for worst case scenarios, which were correctly reflected in the above testing.”
